SUSQUEHANNA RIVER BASIN  
DALTON RUN, LACKAWANNA COUNTY  
PENNSYLVANIA

GLENBURN POND DAM  
NDI ID NO. PA-00371  
DER ID NO. 35-1

PHASE I INSPECTION REPORT  
NATIONAL DAM INSPECTION PROGRAM

PHASE I INSPECTION REPORT  
NATIONAL DAM INSPECTION PROGRAM  
BRIEF ASSESSMENT OF GENERAL CONDITION  
AND  
RECOMMENDED ACTION

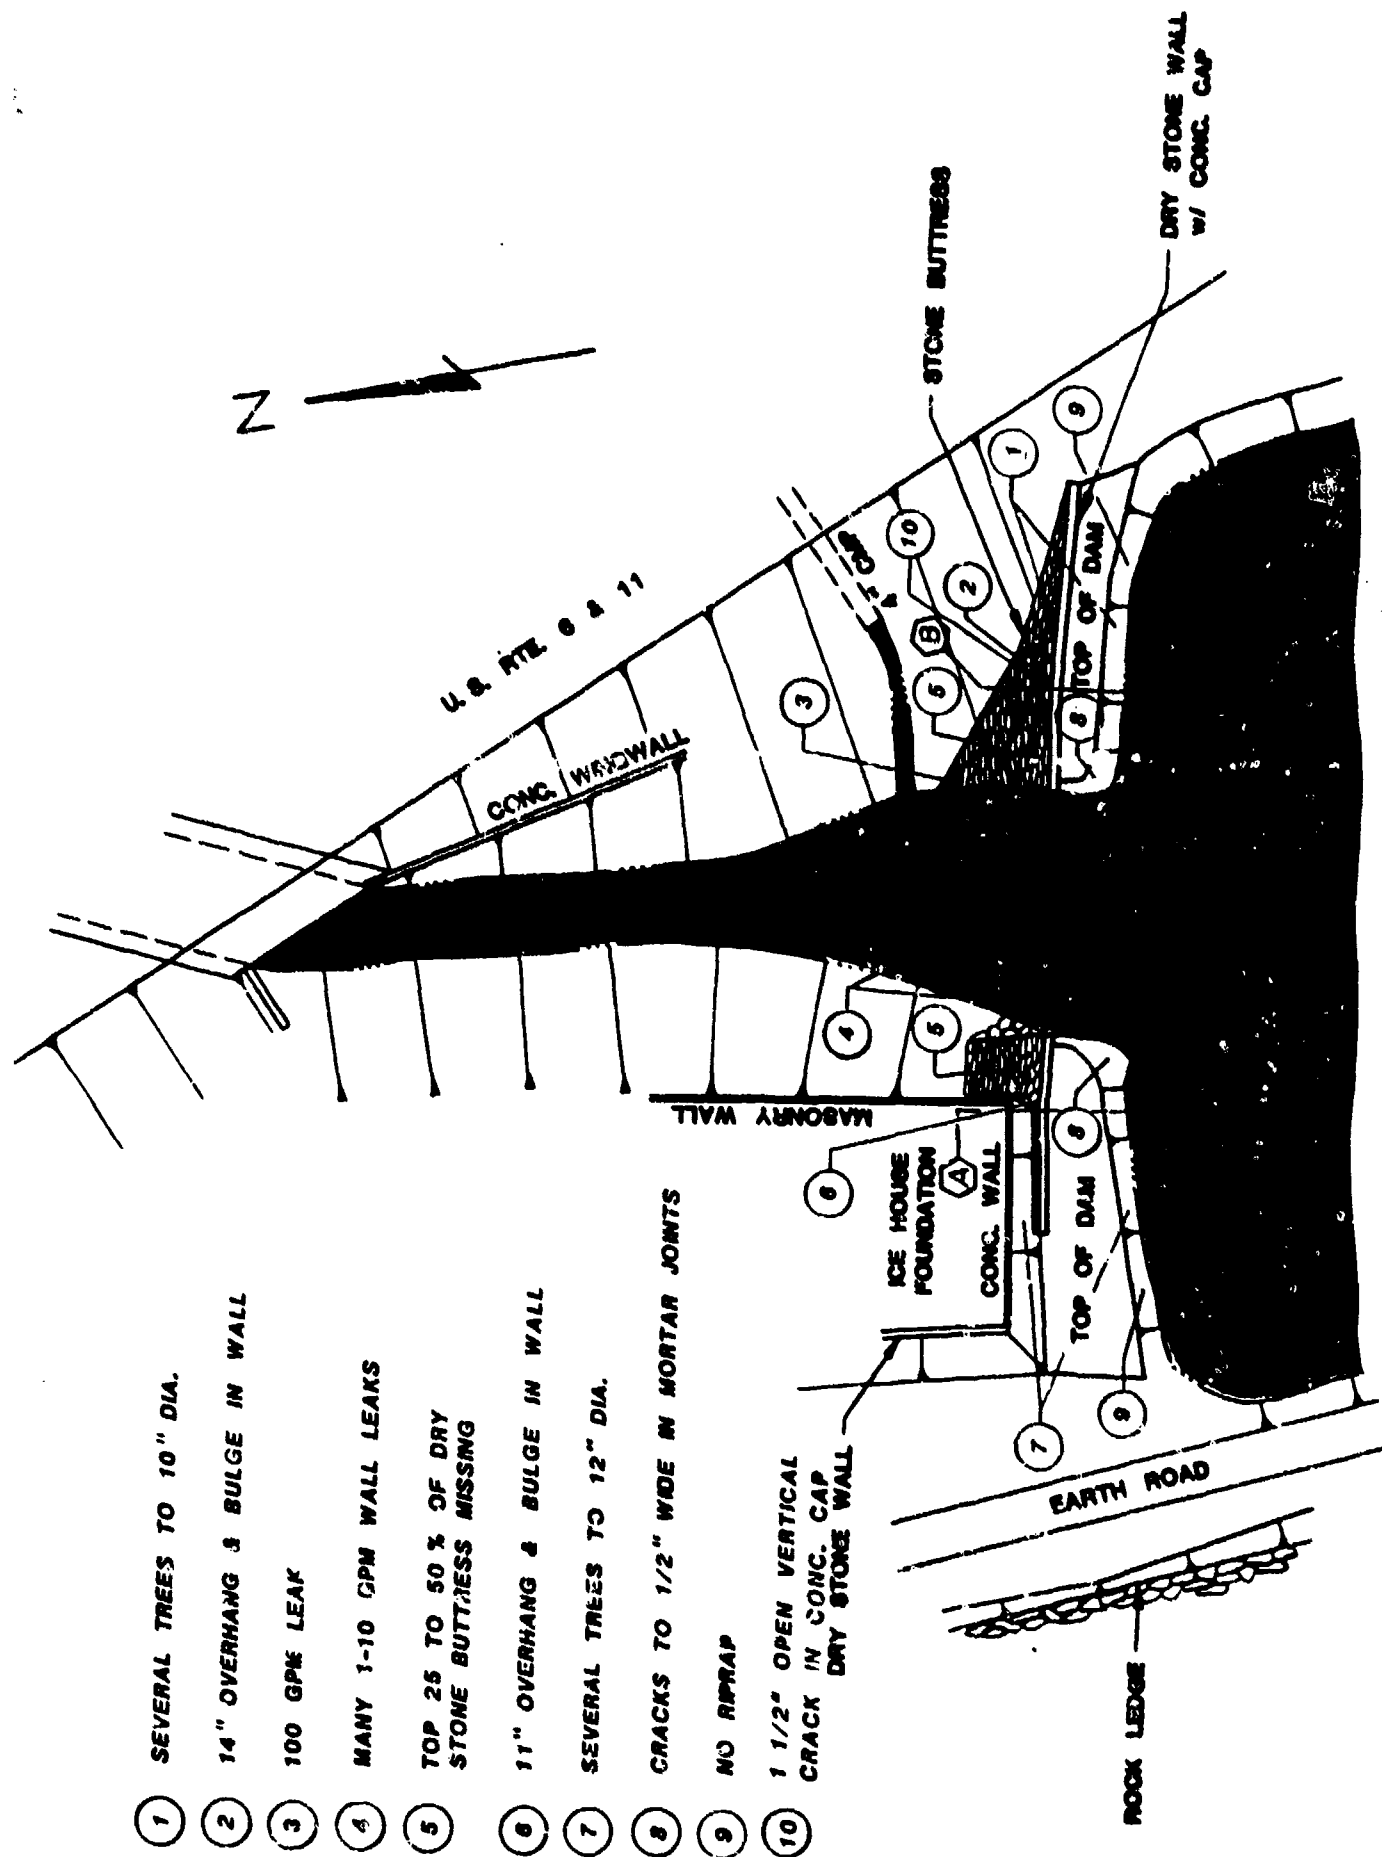
# GLENBURN POND DAM GENERAL PLAN - FIELD INSPECTION NOTES

a. General: The overall appearance of the dam is poor. Deficiencies observed during the field inspection are illustrated on the General Plan, Exhibit A-1, Appendix A. The profile and typical sections of the dam are presented in Exhibits A-2, A-3 and A-4, and are based on field survey made the day of the inspection. The survey datum for this inspection is based on interpolation of USGS contour lines shown on Exhibit A-1. On the inspection date (May 14, 1981), the lake level was at elevation 1034.5, about 0.2-foot above the spillway crest. Pertinent features observed are shown in Photographs, presented in Appendix C.

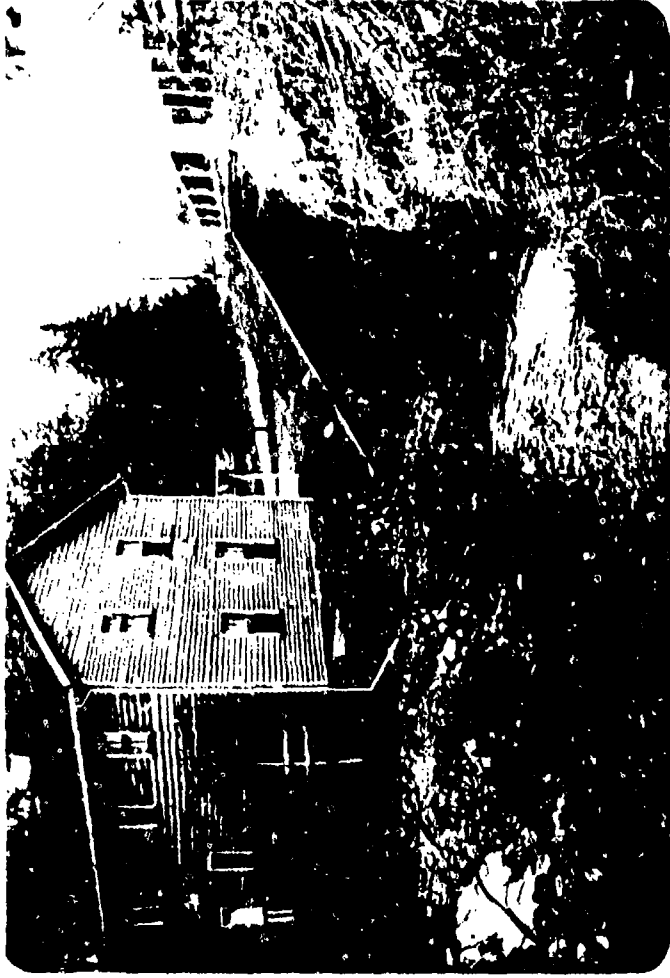
9. VIEW OF DUMPED STONE TO PROTECT HOME  
DOWNSTREAM OF HIGHWAY BRIDGE
